Manhole Inspection Summary

Manhole # S49M__033MH

Location Address: **940 s lakewood av**

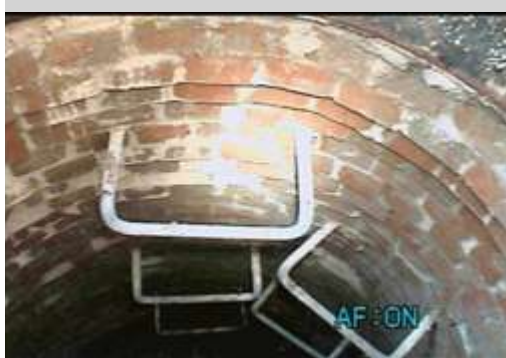
Miscellaneous

stairs

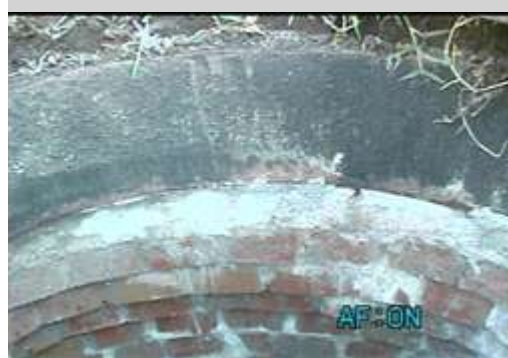
Defect 1

Frame Offset: **2** (in.) Condition: ☒ Sound ☐ Cracked ☐ Leaks

frame adjustment offset

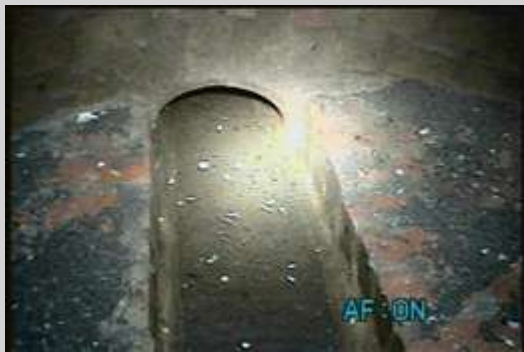
12 O'Clock Outflow

8 in. Circular Gravity Sewer
Pipe Out @ 12 O'Clock

Deposits: ☒ None ☐ Mud ☐ Sludge ☐ Debris ☐ Grease

Infiltration: **None**

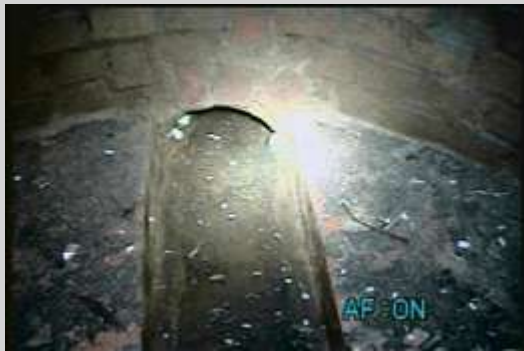
6 O'Clock Inflow

8 in. Circular Gravity Sewer
Pipe In @ 6 O'Clock

Deposits: ☒ None ☐ Mud ☐ Sludge ☐ Debris ☐ Grease

Infiltration: **None**
